HOLY LOCH FLEET MOORINGS INSPECTION REPORT(U) NAVAL  
FACILITIES ENGINEERING COMMAND WASHINGTON DC CHESAPEAKE  
DIV 15 OCT 82 CHES/NAVFAC-FPO-1-82(22)

HOLY LOCH  
FLEET MOORINGS  
INSPECTION REPORT

FPO-1-82(22)

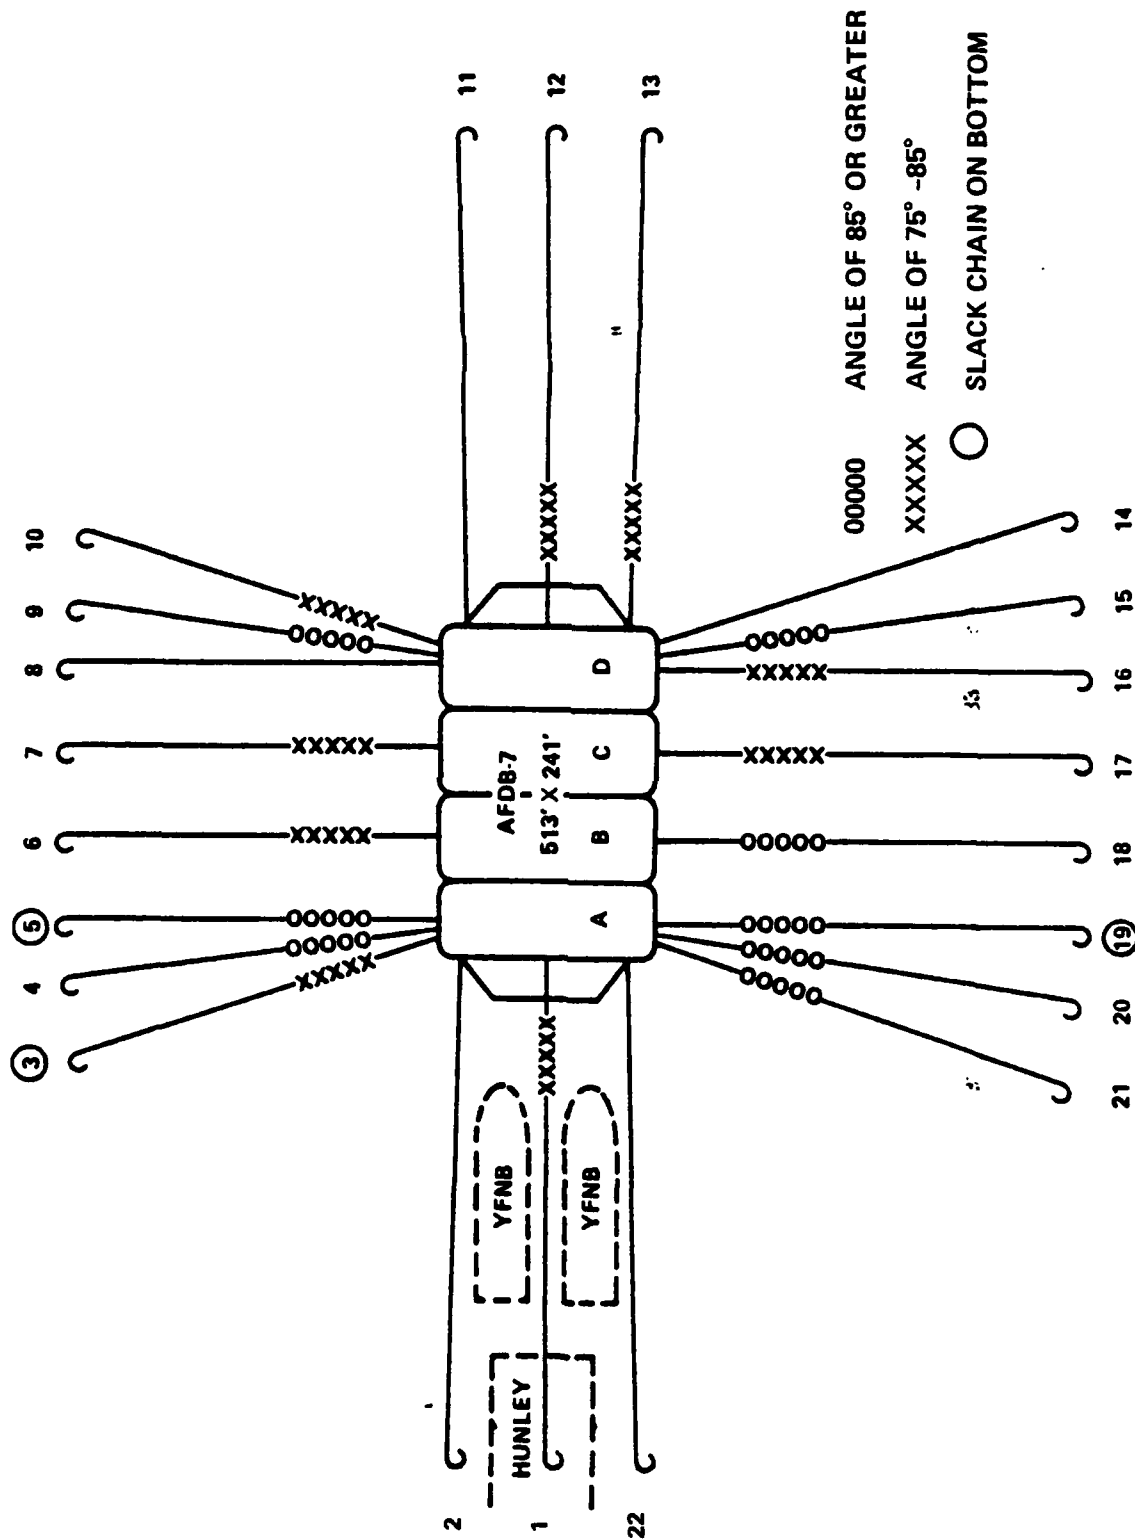
Figure 6. Summary of Catenary Data

- No anchors or sinkers were located; all legs were buried in bottom mud a relatively short distance from the floating dock.
- Three legs were noted to have slack chain resting on the bottom; 36% (8 of 22) of the legs had surface chain angles of greater than 85° from the horizontal; 41% (9 of 22) had angles of 75° - 85°; 32% (7 of 22) of the lateral distances were less than 18'; average lateral distance was 45' (see Figure 6).

- The chain in Section II of Leg #22 which measured less than 80% of original wire diameter must be replaced as soon as possible.
- An engineering analysis of AFDB-7 mooring design should be conducted in order to define the optimum catenary of each leg; pending results of such an analysis, a number of legs should be repositioned to tighten the catenary prior to the 82 - 83 winter season.

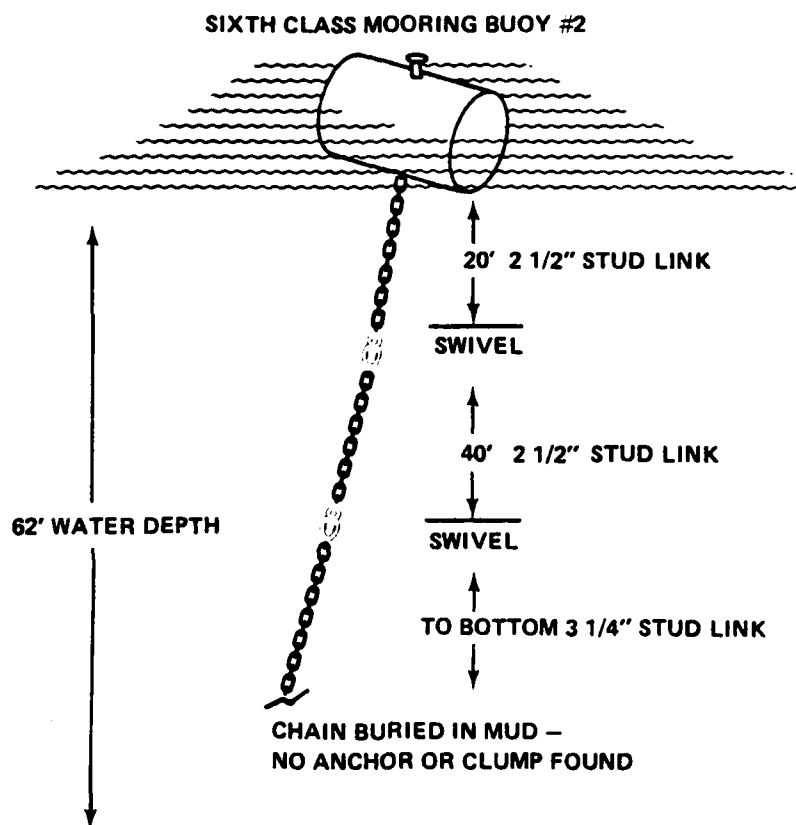
Figure 8. Sixth Class Mooring #2, Schematic

ITEM	SIZE	LOCATION OF MEASUREMENT	CONDITION (note)			REMARKS
			+90%	+80%	UNK	
Buoy, Cylindrical, 3rd Class	10' long 6' diam.	-----	-	-	-	British 3rd class buoy; excellent condition: no holes, dents, or pitting; medium marine growth(½")
Mooring Ring	UNK.	not measured			XXX	Divers unable to reach buoy topside; condition assumed sat.
Buoy Shackle	Unk.	not measured			XXX	Inside buoy - divers unable to measure
Riser Chain, studlink	2½"	20' depth	XX D			
Swivel	UNK.	not measured	-	-	-	Located at 20' depth; condition assumed satisfactory
Riser Chain, studlink	2½"	60' depth	XX D			
Swivel	UNK.	not measured	-	-	-	Located at 60' depth; condition assumed satisfactory
Riser chain, studlink	¾"	72' depth	XX D			
Anchor swivel and Anchor	UNK	-----	-	-	XXX	Not located - chain buried
<b>SUMMARY:</b> Mooring is in good-to-excellent condition.

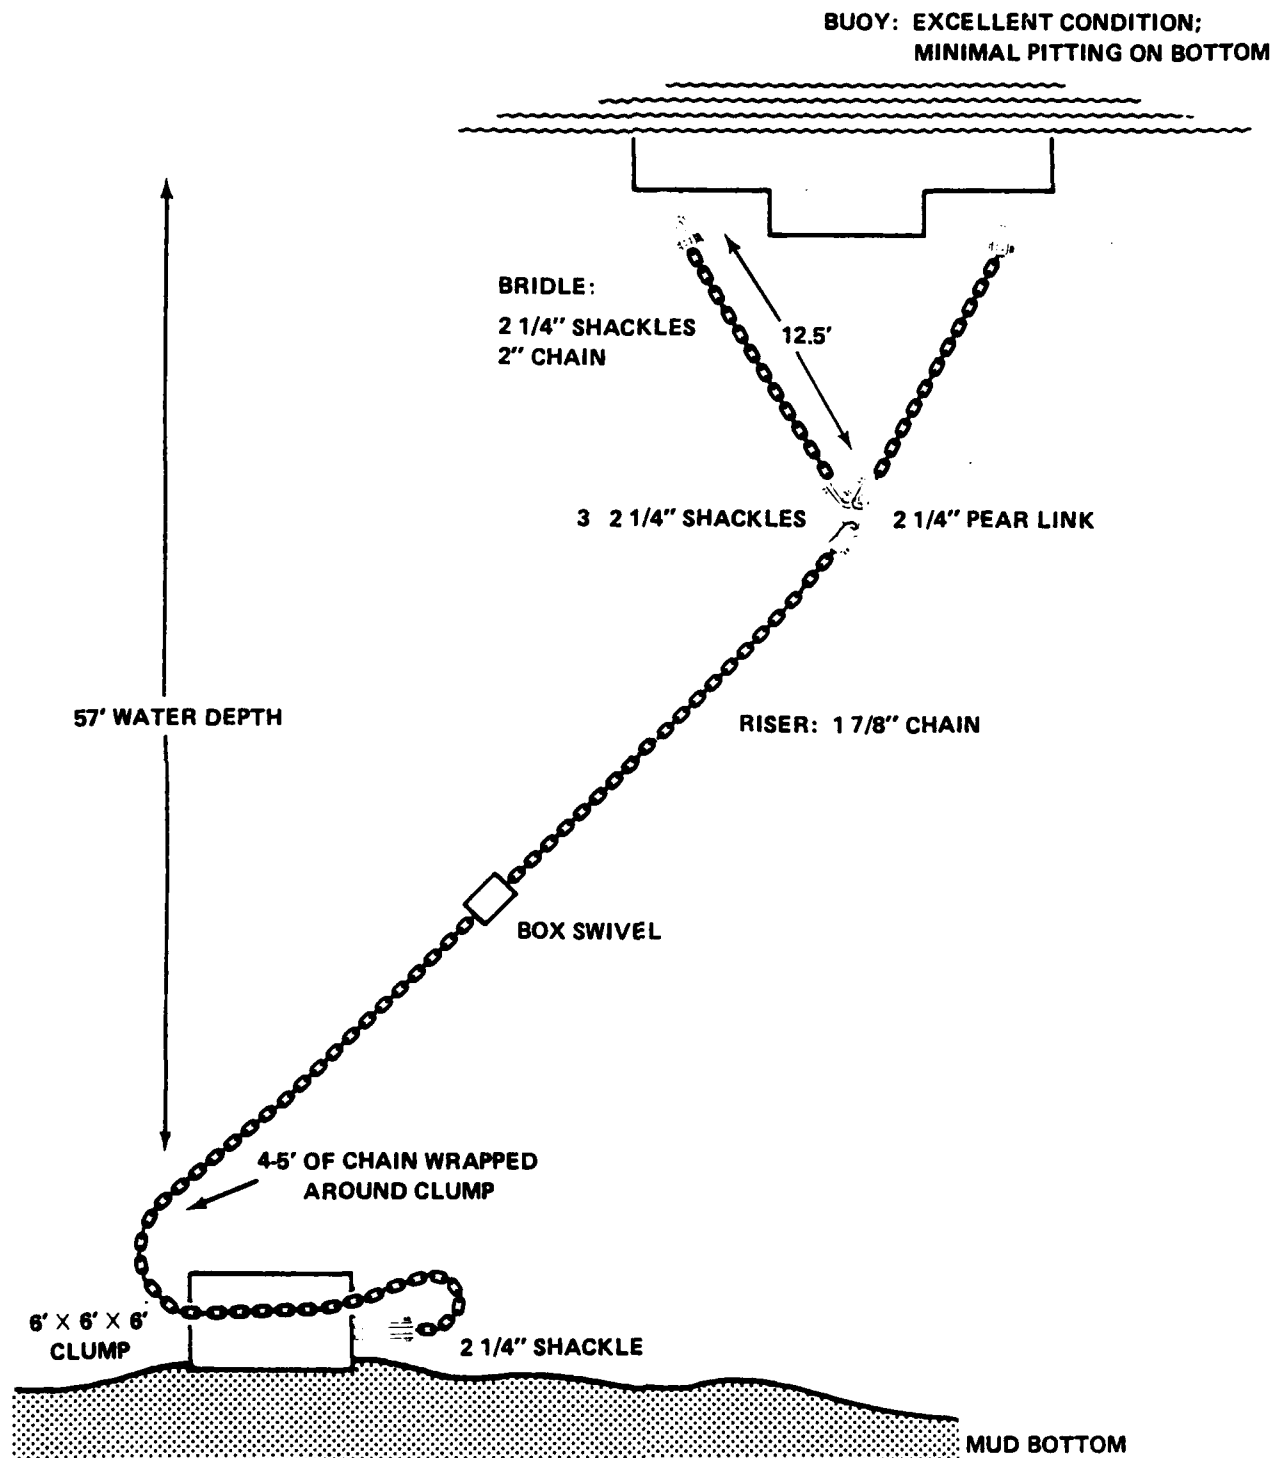
Figure 10. Starboard (Green) Navigation Buoy, Schematic

**3.3.1 Findings.** The condition of these buoys is generally good-to-excellent. The topside portion of each of the buoys is in good condition; minimal pitting was observed below the waterline. The bridles and risers are in good condition; all double link measurements were +90%. The anchors of both buoys were located and there was no evidence of dragging. The only notable observations were the existence of a box swivel in place of a standard swivel in one of the risers, and a 4 - 5' length of riser chain wrapped around the clump anchor, both in the Starboard buoy.

**4.3 Navigation Buoys.** These buoys should remain in excellent condition under the current program of inspection and maintenance administered by the British Navy.

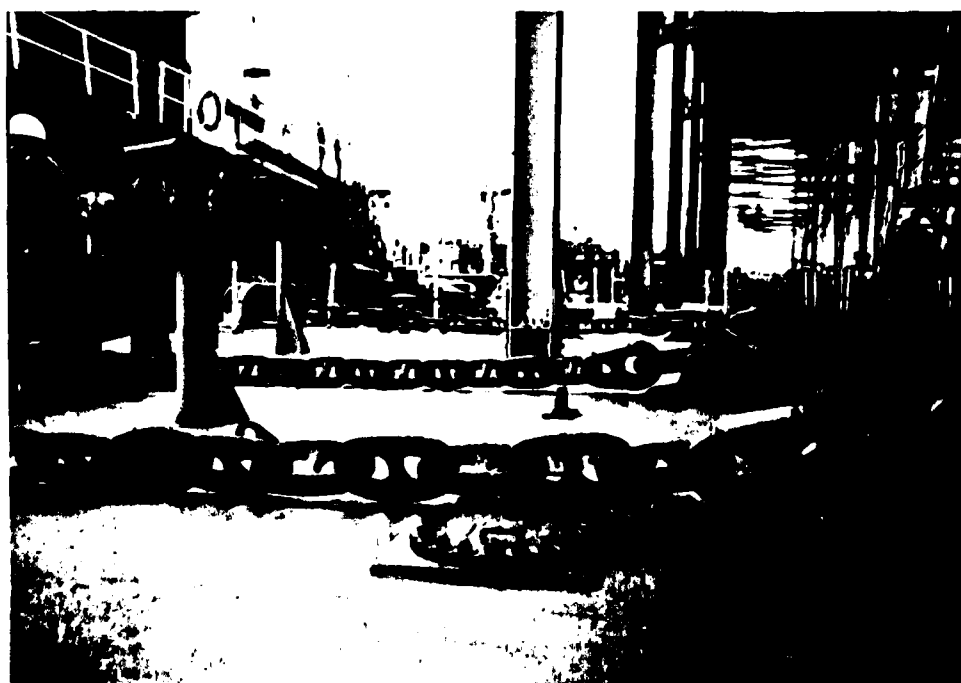
**On-deck arrangement of anchor leg, showing pad-eye, anchor joining link (red), and stud-link chain.**

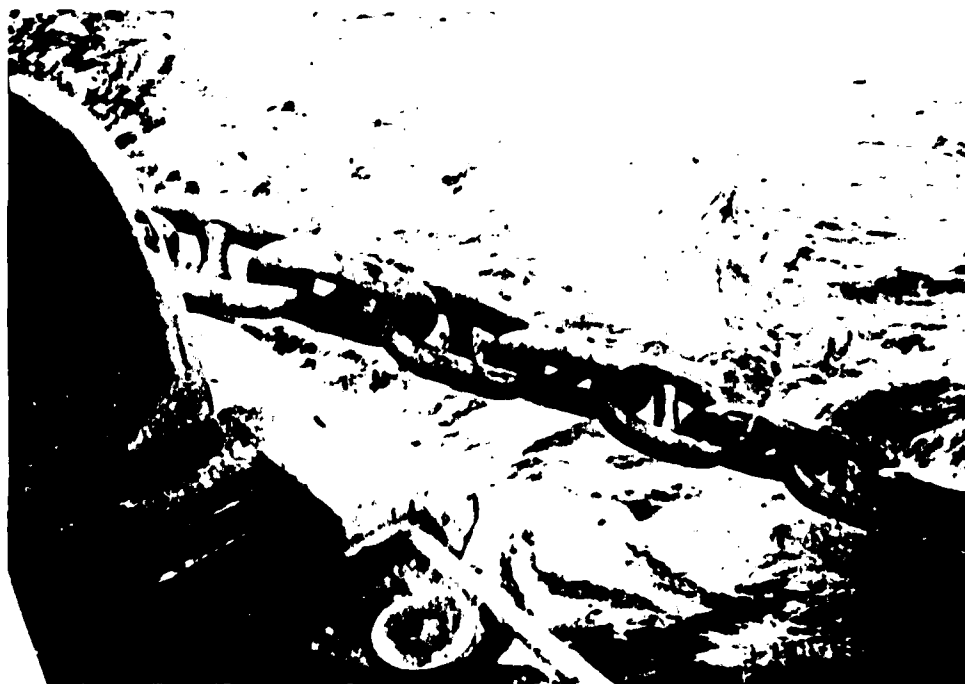
Chain in very good condition, showing light rusting and some marine growth near the waterline.
